**LONG TERM MONITORING PROGRAM
YEAR 1 IMPLEMENTATION REPORT
STUDY AREA 7 SEDIMENT REMEDY
JERSEY CITY, NEW JERSEY**

Honeywell
Morristown, New Jersey

**ENVIRON**
ENVIRON International Corporation
Princeton, New Jersey

February 2015

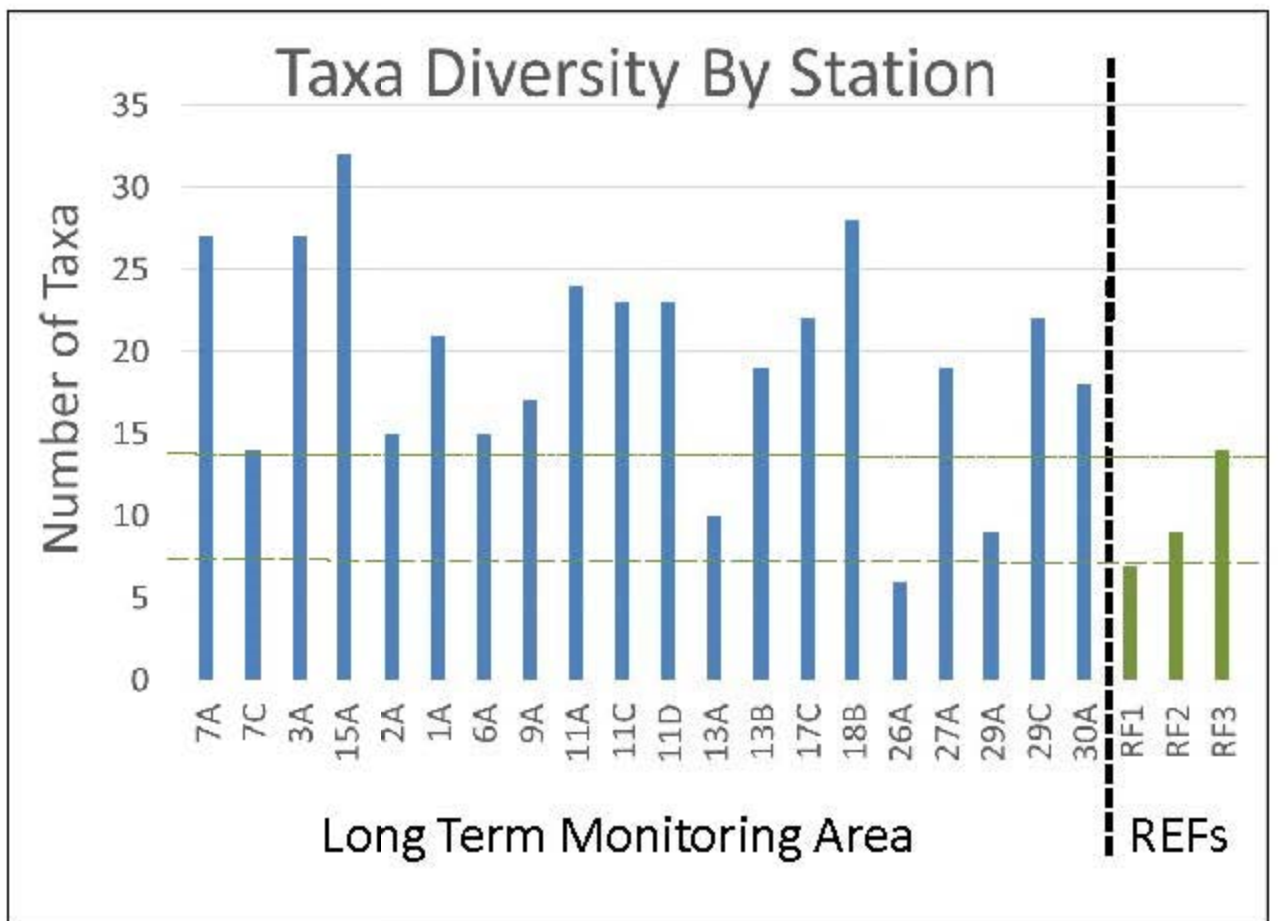
— Upper end of diversity measurements from the reference area monitored.

— Lower end of diversity measurements from the reference area monitored.

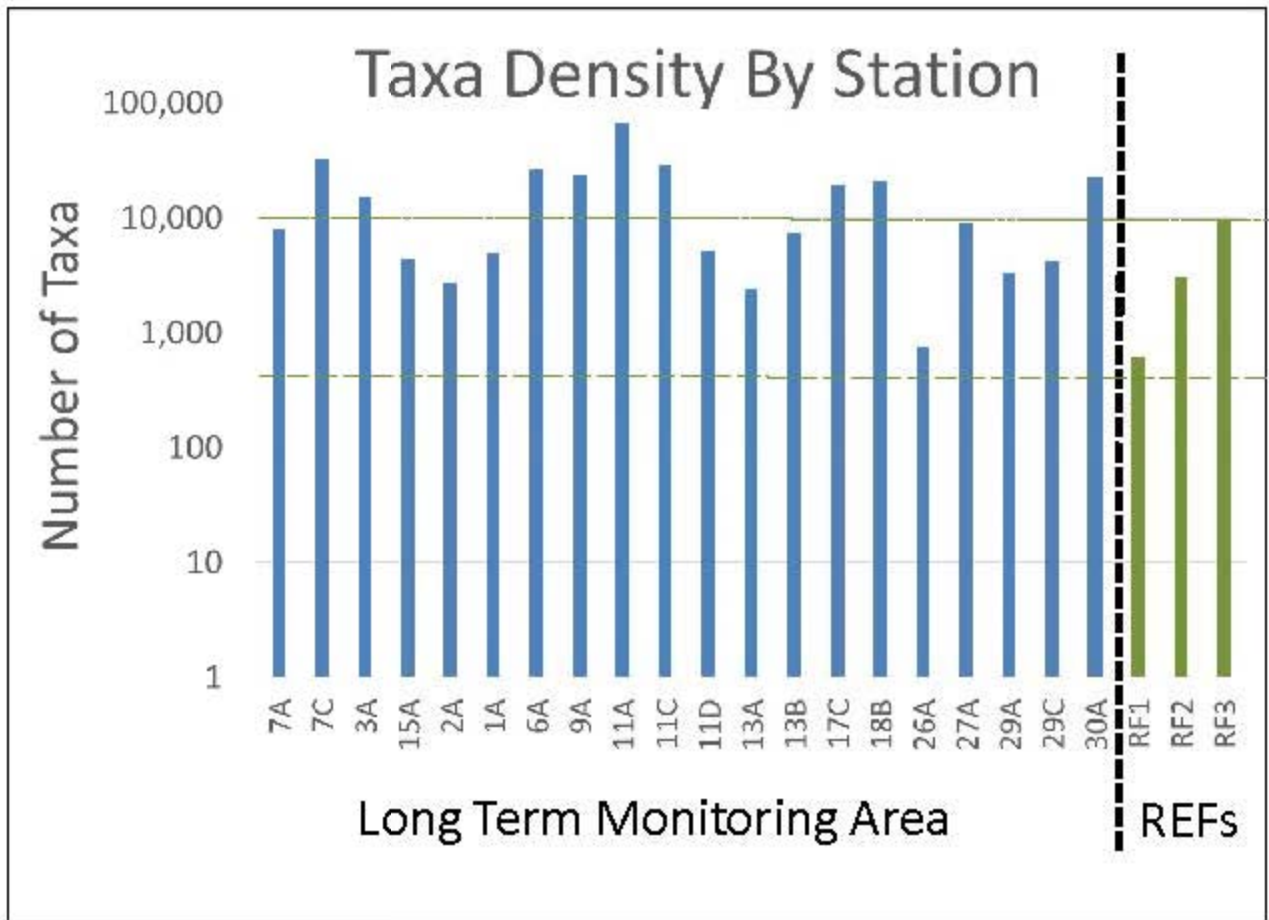
— Upper end of density measurements from the reference area monitored.

— Lower end of density measurements from the reference area monitored.

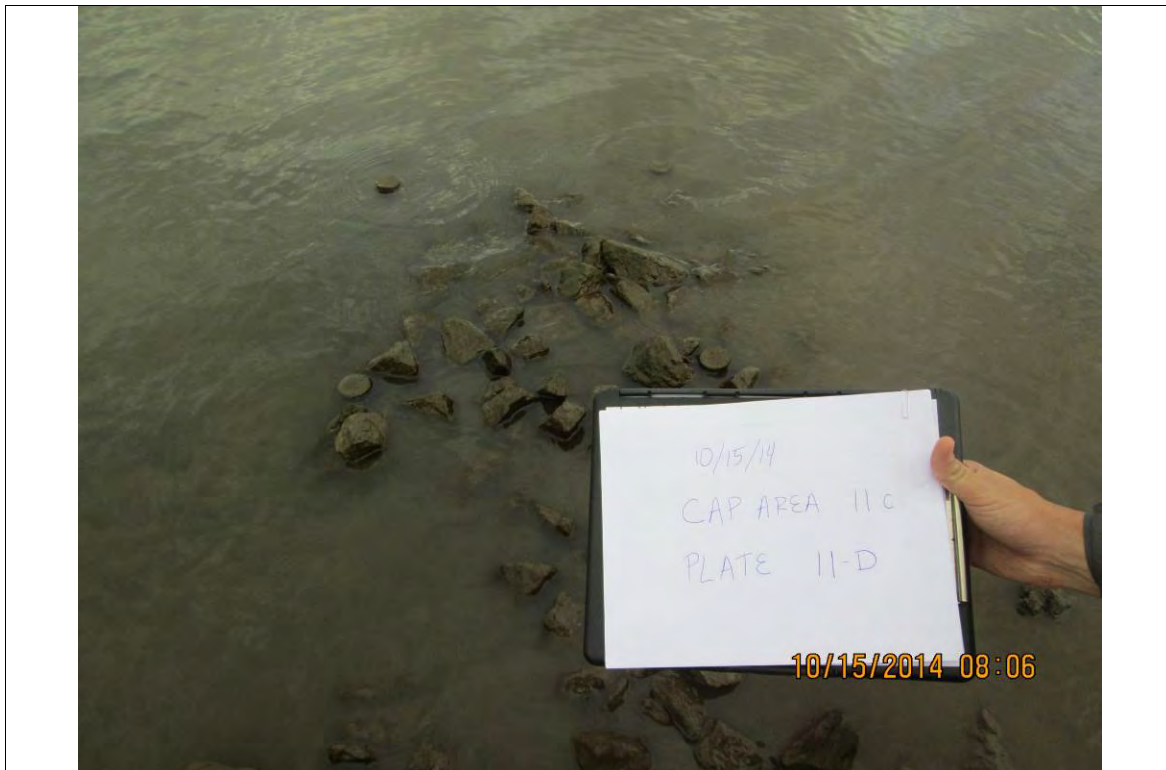
Inspections of the 6 plate locations within intertidal areas (i.e., plates 6A, 11D, 13A, 13B, 26A, and 30A) revealed that for all but one GPS-defined plate location (i.e., plate 11D in Cap Area 11) the posts of the long-term monitoring plates were not observed and armor stone was present. This indicates that the plates are buried and no observable loss of cap material has occurred. At the GPS installation location of plate 11D, the plate was found to be covered by the armor layer, but the very top of the plate posts was observed, indicating at least 7-inches of cap coverage at this location. However, no signs of erosion of the cap were observed.

Photo 3: Inspection of intertidal plate 11D in Cap Area 11C

11D	2014	Intertidal	10/15/2014	0:29	Top of plate posts	688103.13	603577.23	0	Y	Inspection conducted at low tide, when cap area was exposed. The very top of the plate legs were observed at the as-built coordinates. No signs of erosion were observed; rather, siltation (2 to 4 inches) observed on cap material around the plate location.
13A	2014	Intertidal	10/15/2014	1:23	None	686834.71	602965.79	0	Y	Inspection conducted at low tide; at the time of inspection, there were approximately 8 to 12 inches of water above cap materials. Plate was not observed at the as-built coordinates. No signs of erosion were observed; rather, some siltation and biological growth observed on cap material.
13B	2014	Intertidal	10/15/2014	0:41	None	687090.08	603046.37	0	Y	Inspection conducted at low tide, when cap area was exposed. Plate was not observed at the as-built coordinates. No signs of erosion were observed.
15A	2014	Subtidal	10/21/2014	11:02	(2:23) Crab eggs (2:12, 5:29) Crabs	685753.88	601541.97	0	Y	Plate was not observed at the as-built coordinates. No signs of erosion were observed; rather, siltation (0 to 3 inches) and significant biological growth, crabs and crab eggs observed on cap material.

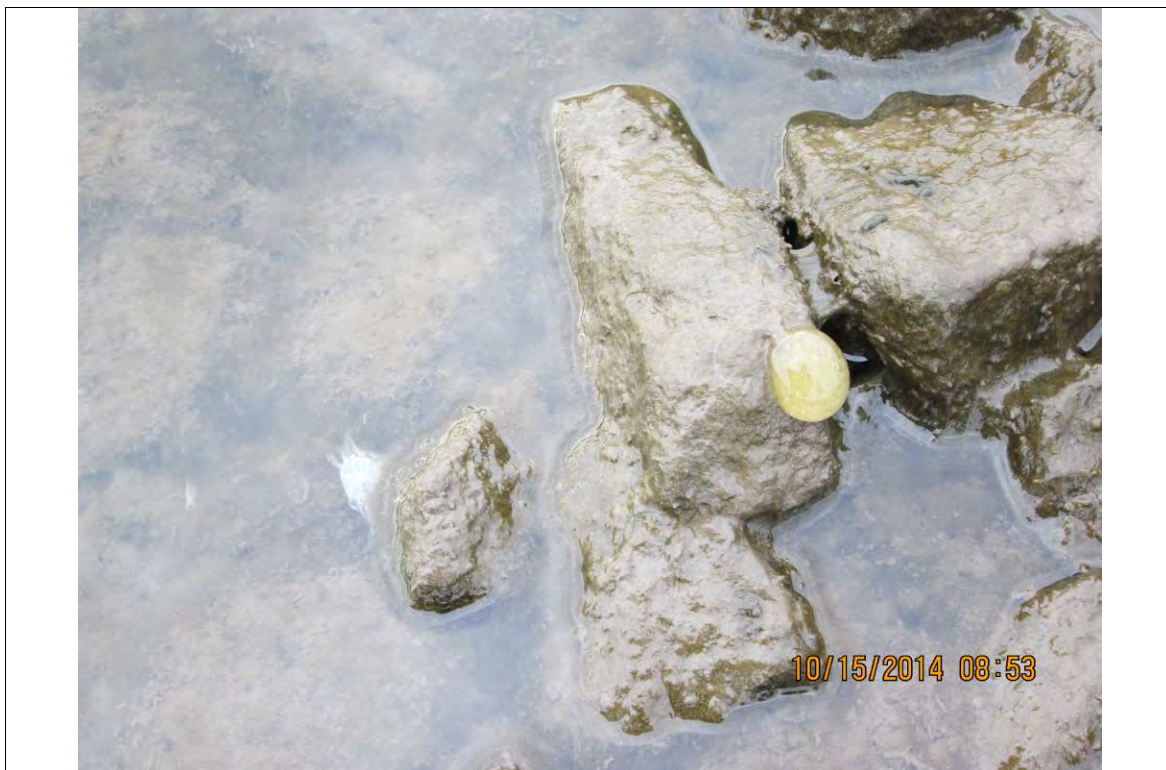
Photo 4: Crab eggs observed on sediment cap armor layer in intertidal area

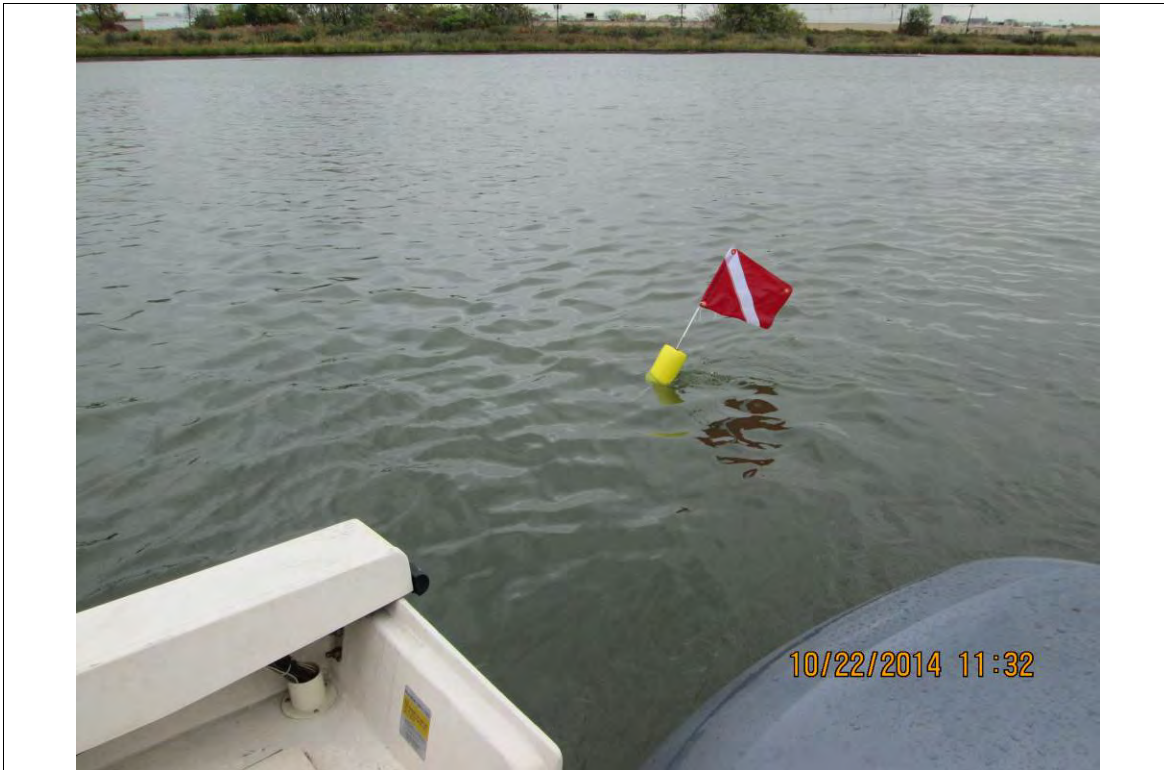
Photo 5: Buoy-marked plate location for cap thickness verification in subtidal area

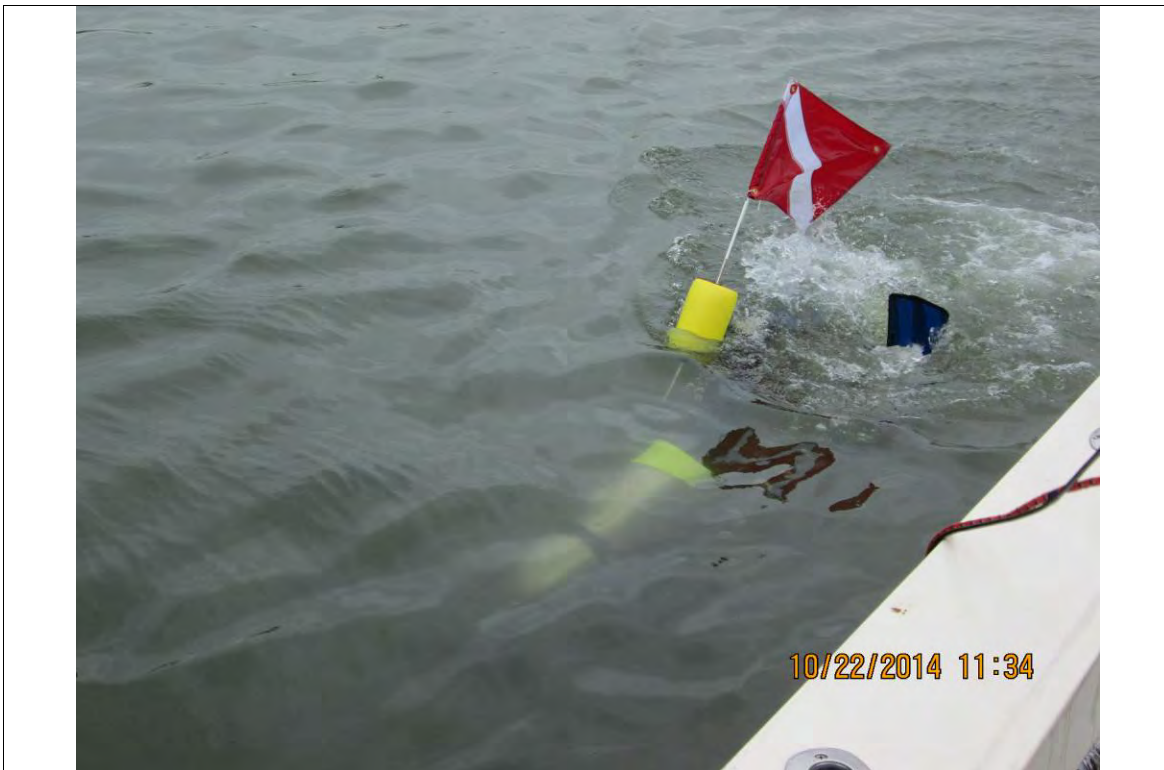
Photo 6: Cap thickness verification by AquaSurvey diver in subtidal area

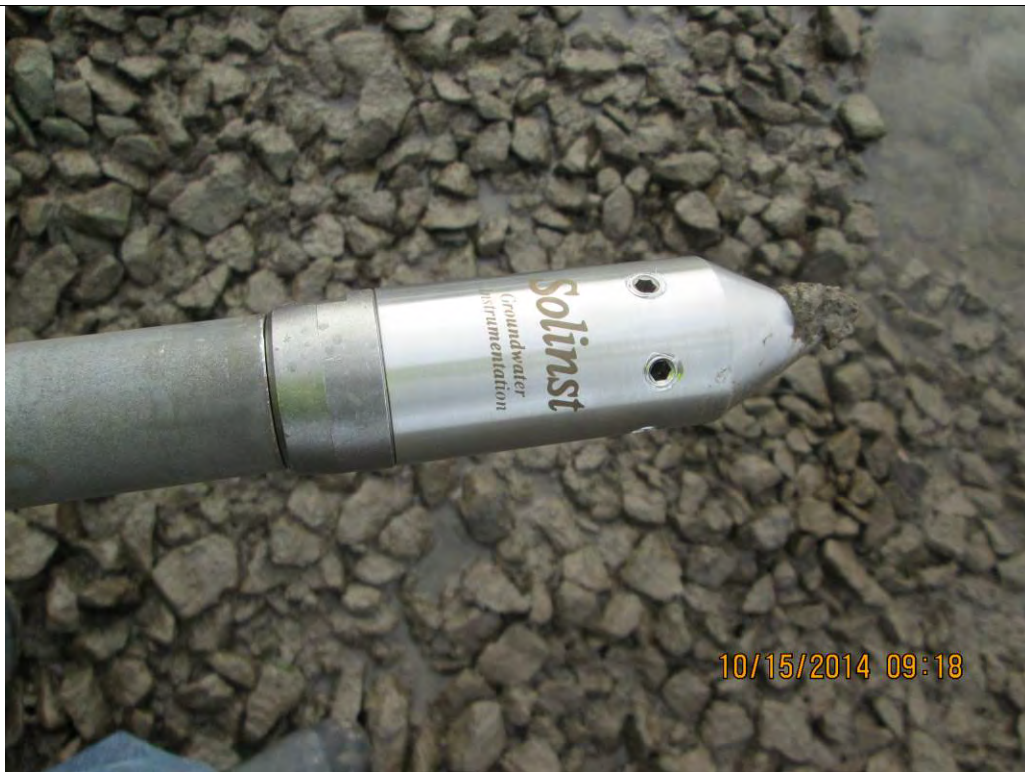
Photo 7: Solinst® Drive Point Profiler – pore water sampling device

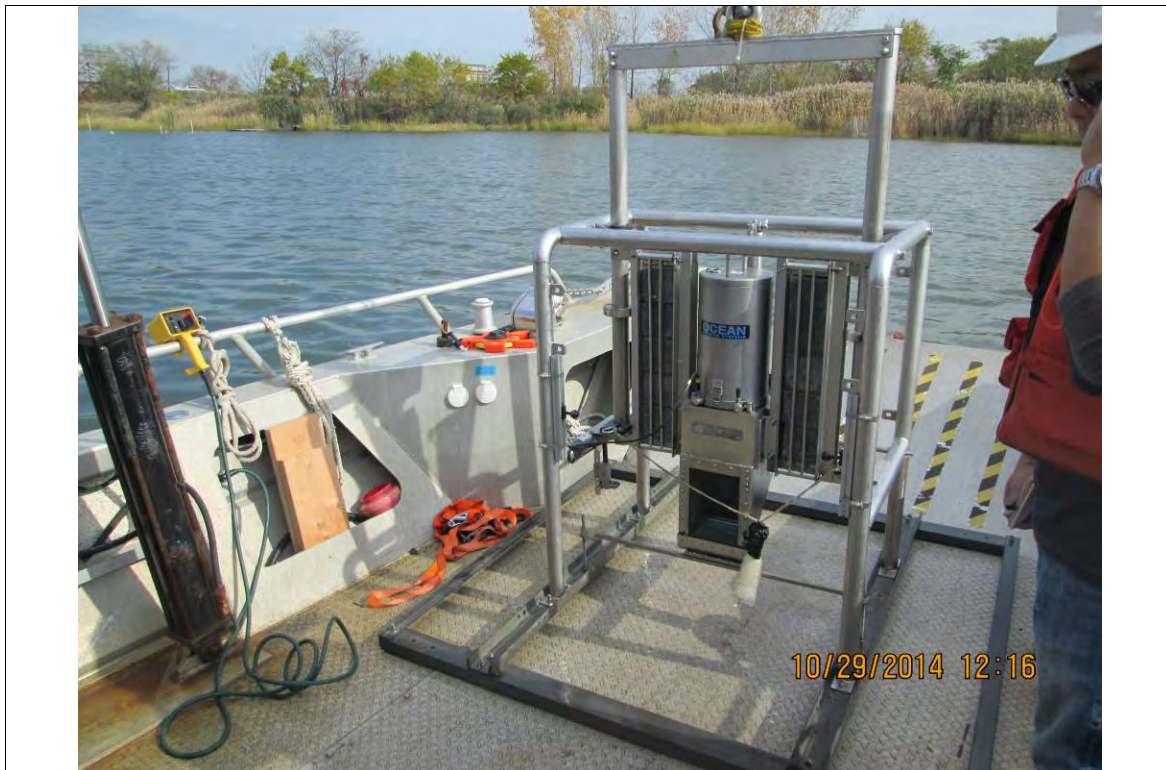
Sediment profile images were collected using a digital sediment-profile imaging camera system (Ocean Imaging Systems, North Falmouth, MA) deployed from the research vessel (R/V) Tesla. The camera prism was mounted on an assembly that moves up and down within a stainless steel frame by allowing tension or slack on the winch wire. As the camera was lowered, tension on the winch wire kept the prism in the up position. Once the camera frame touched the bottom, slack on the winch wire allowed the prism to vertically intersect the seafloor. The rate of fall of the prism (6 cm/second) was controlled by an adjustable passive hydraulic piston, which minimized the disturbance of the sediment-water interface. The camera was able to obtain images of up to 20 cm (approximately 8 inches) in the upper sediment column.

Photo 13: SPI Camera staged on deck of vessel

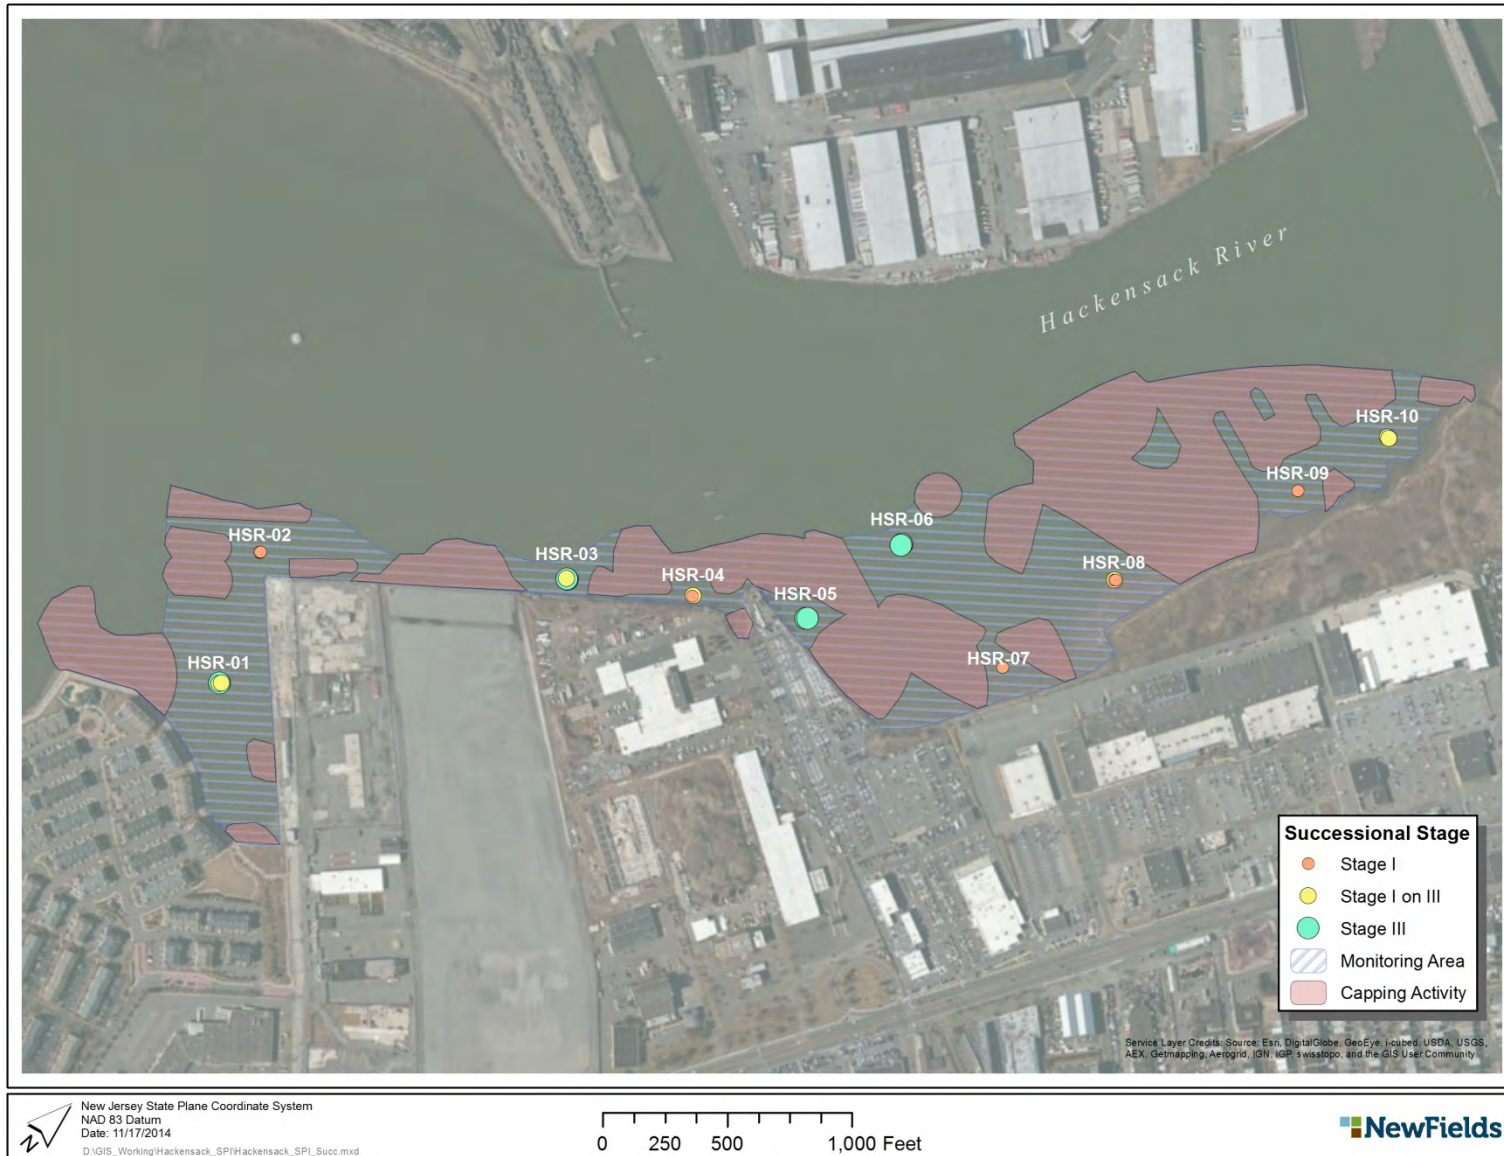
Figure 13. 2014 SPI results for infaunal successional stage.

The distribution of infaunal successional stage at the monitoring sites is presented in Figure 13. All of the 10 monitoring stations exhibited Stage I succession in at least a single replicate SPI image. Stage I succession, the pioneering stage, was characterized by tubicolous, surface dwelling polychaetes as well as polychaetes present near-surface. Stage I succession was observed in all three replicate SPI images at station HSR-02; sediments at this station consisted of denser fine sands resulting in lower prism penetration. Stage I succession may be the dominant successional stage for this sediment habitat type (Figure 4). Stage II succession, the transitional stage between Stage I and III, was observed at five of ten stations and was
